PROPOSAL

Dr C Pendarvis  
Naomi AME Zion Church  
Date: 8/25/2016

As I have previously informed you, it is necessary to obtain funding for the repairs of the brick wall surrounding and above the side building entrance on West 25th street. Bulging, cracked, loose and spalled bricks were visible to the engineer making the inspection of the work being performed at your church. He informed me that this is a safety violation and will be noted by the Department Of buildings and need to be corrected before an inspector visits the church. In the photos included you can see that beginning with the coping stones and parapet wall down to the steel angles on the window both above and below as well as the top and sides of the entrance door all need to be removed and replaced in order to correct the hazard.

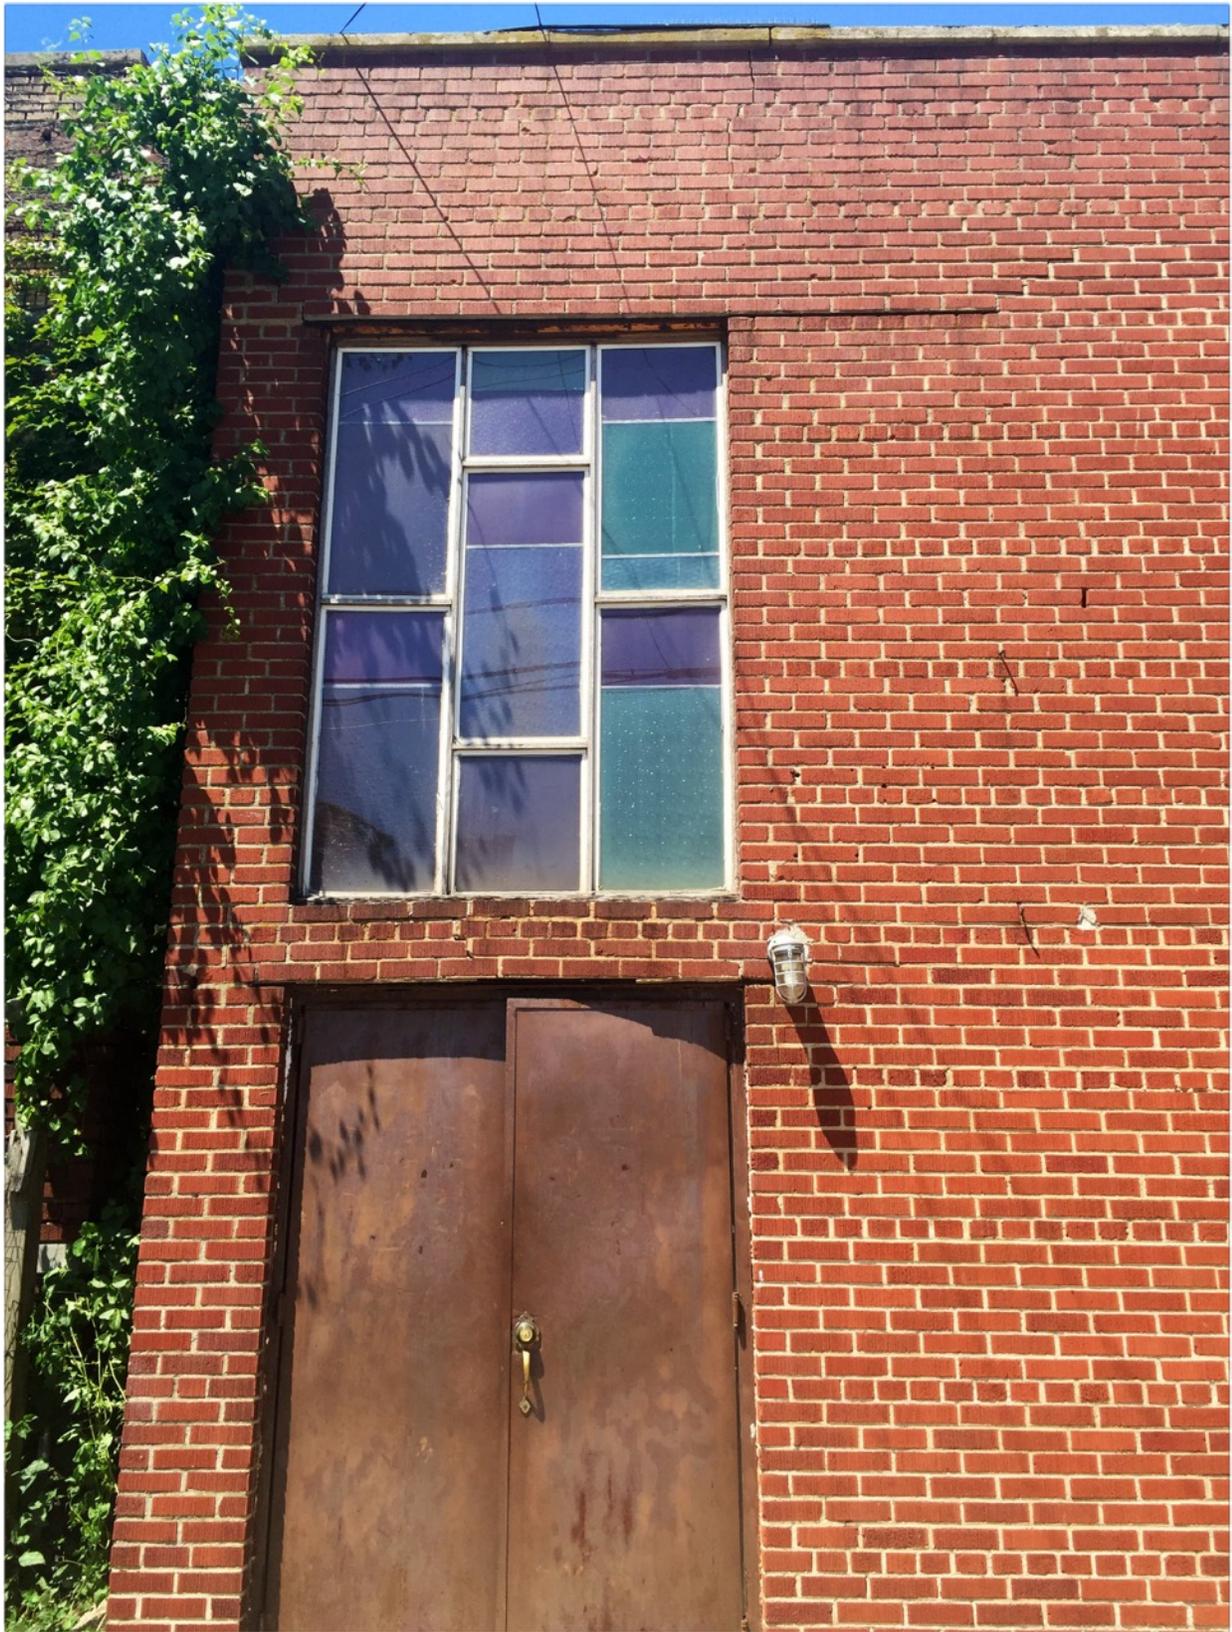
#1

**Photo #1:** Here you could see the entire area of work to be performed, beginning with the parapet on top of the brick wall a crack is visible that comes down the middle of the wall.

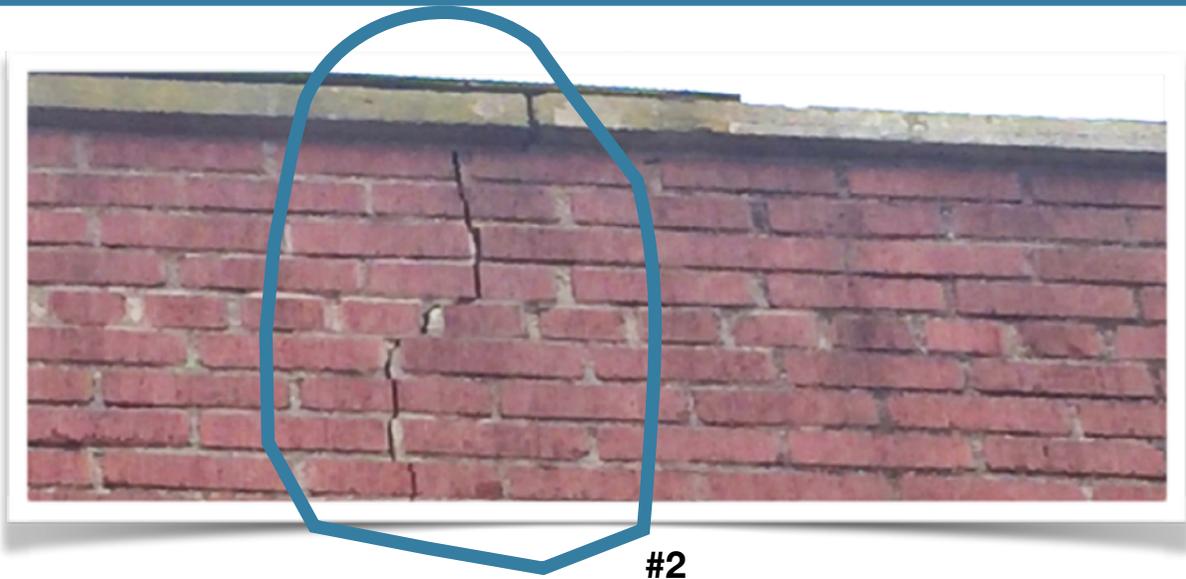
**Photo #2:** A close-up of the cracked line mentioned on photo #1

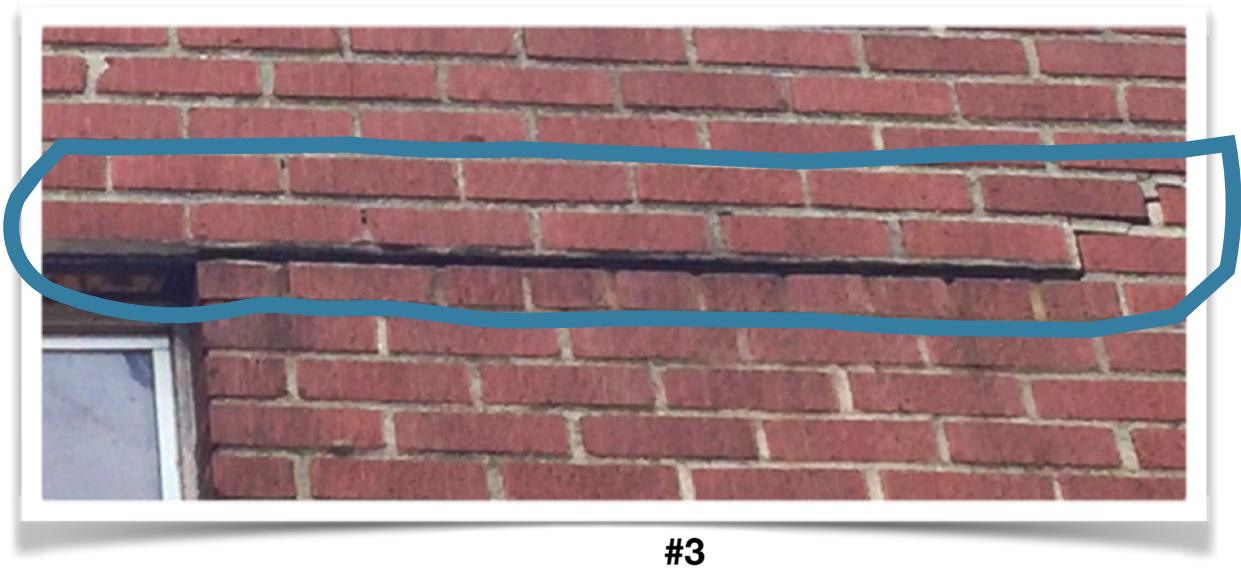
**Photo #3:** Shows the disintegrating steel angle line above the window and the brick above Bulging out.

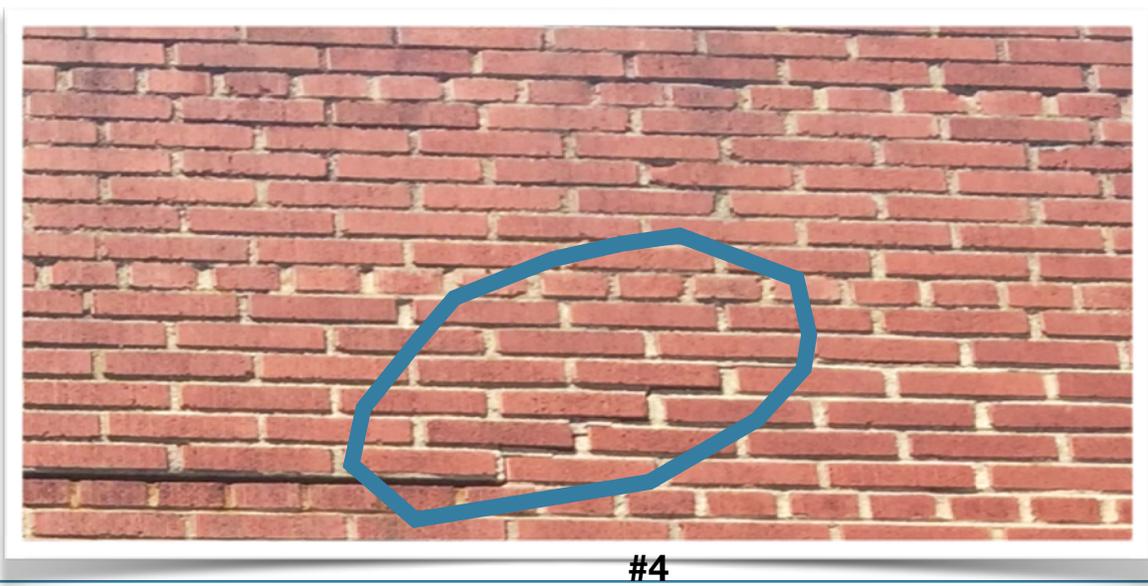
**Photo #4:** This is another view of the steel angle line above the window, notice to the right how the bricks are separating looking like upside down steps.

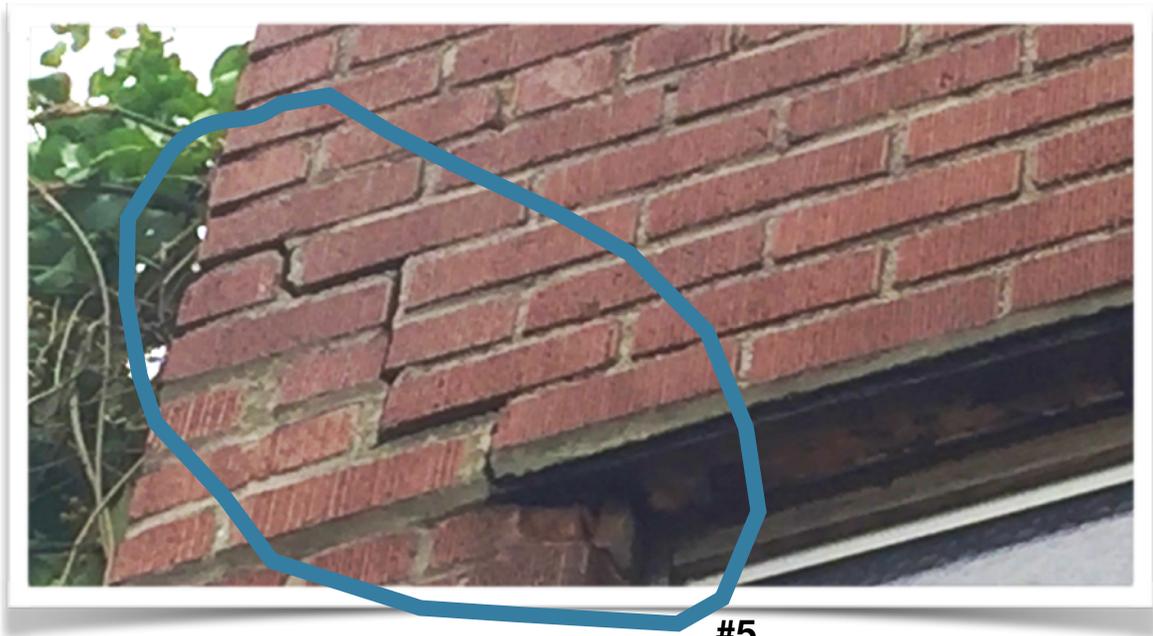
#5

**Photo #5:** This is a view of the left side of the steel angle line above the window showing the brick at the end separating about a ½” from the wall in what it looks like upside down steps.

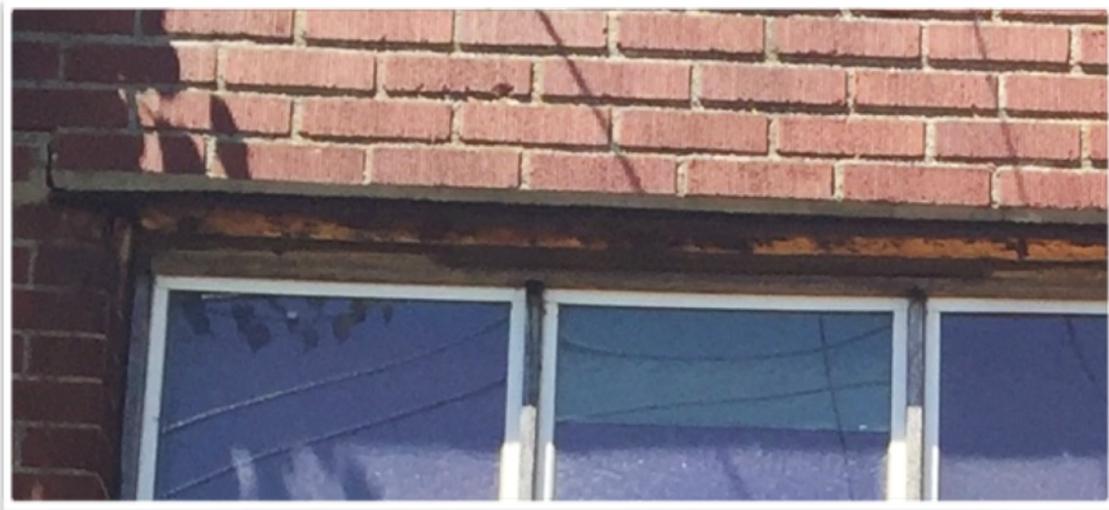
#6

**Photo #6:** The disintegration of the entire steel angle line above the window holding a massive amount of bricks already separating from the wall about a ½”, can give way at any given time which creates a significant hazard.

**Important Note:** The conditions above noted are consistent with the aftermath damage caused by Hurricane Sandy in Coney Island. The salt and water absorbed by the bricks resulted in deterioration and disintegration of the steel angle lines in many properties.

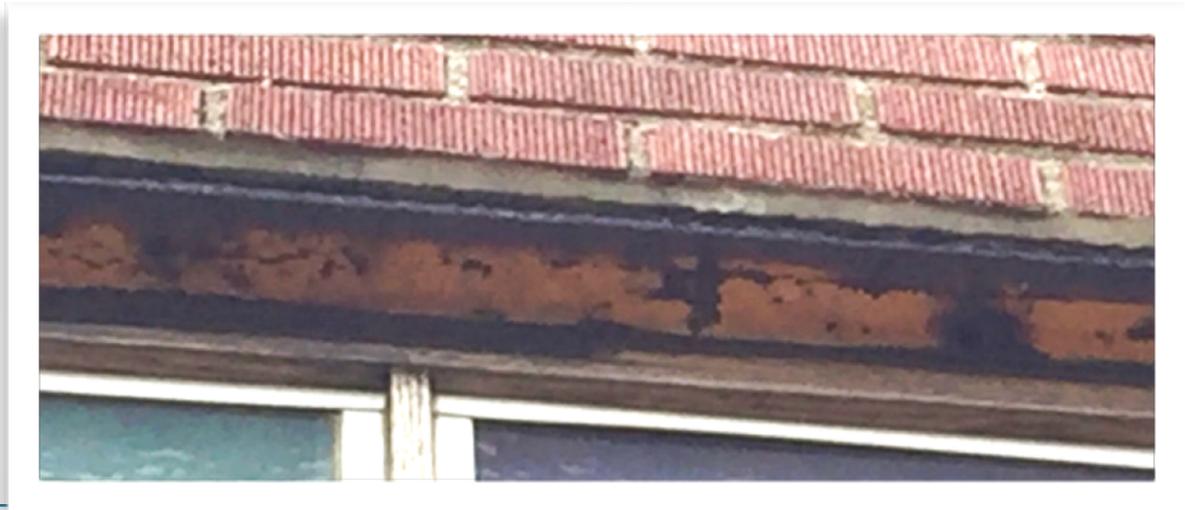
#7

**Photo #7:** This is a better view of the disintegrating steel angle line and how far the bricks is bulging forward and separating from the steel angle line.

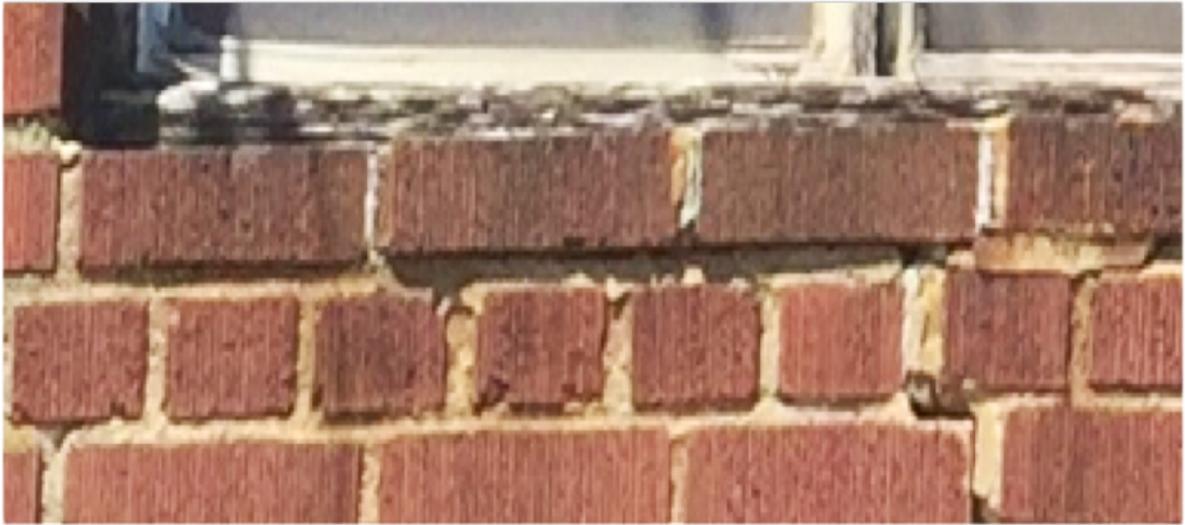
#8

**Photo #8:** This view shows the space between the steel angle lines both the bottom of the window and the top of the door where the bricks have separated from the wall and is bulging forward about 1” in the center. Both steel angle lines have disintegrated.

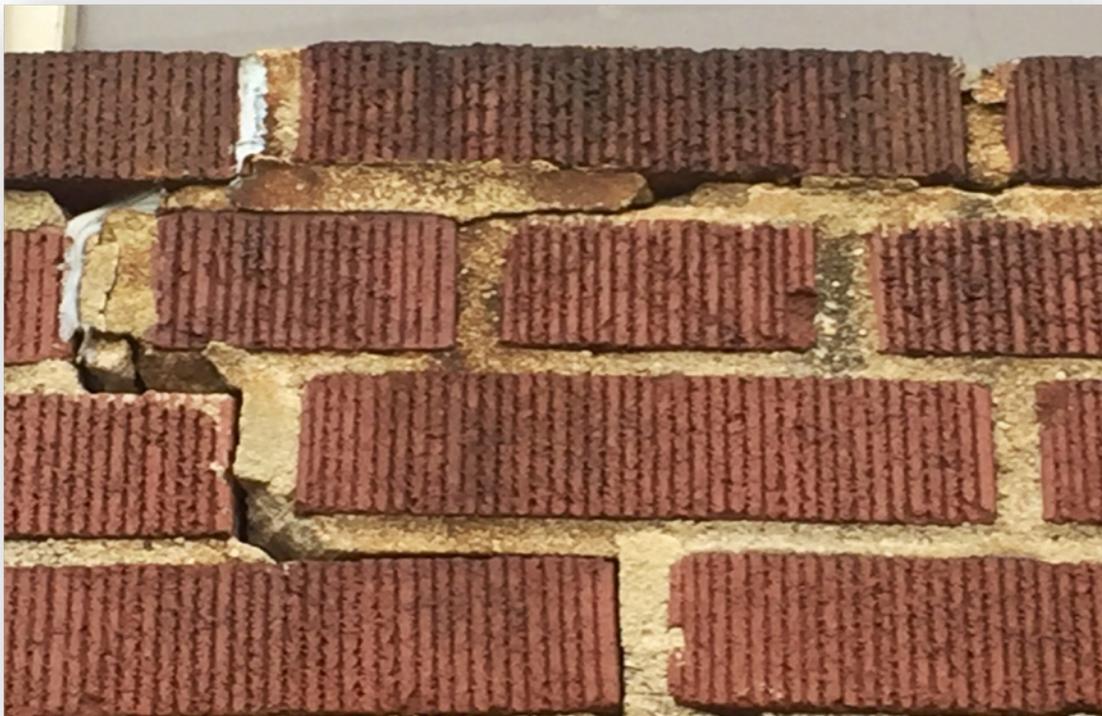
#9

**Photo #9:** This is a closer view of the condition noted on photo #8.

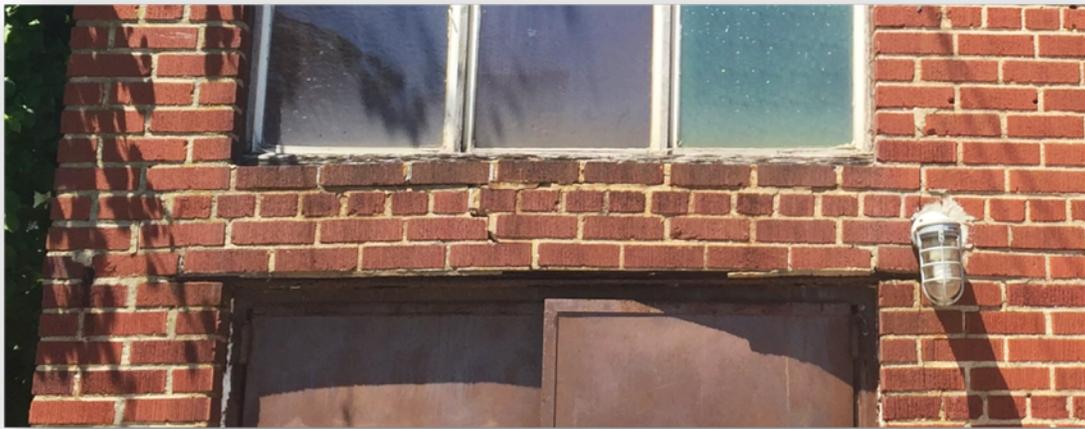
**#10**

**Photo #10:** This is another view of the condition noted on photo #8. Here you could observe the condition of the bricks directly below the window sill.

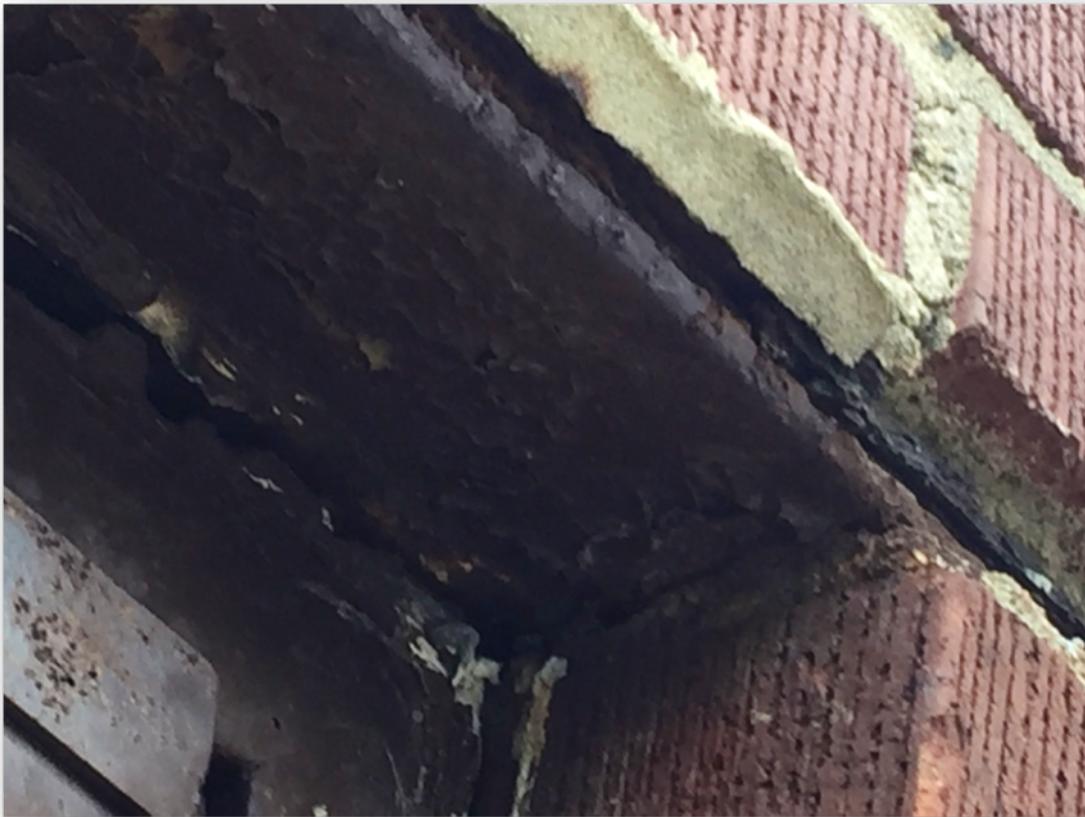
**#11**

**Photo #11:** This photo shows the disintegrated steel angle line directly above the door. Notice that the steel has separated from the steel surrounding the door. This condition is noticeable in the steel angle line on all sides of the door frame.

**note:** As the steel angle lines and the brick are removed for repairs, the window must also be removed. The condition of the window frame is extremely poor as well, and the window cannot be saved and must be replaced. The double doors will be replaced as well.
